# MOTIONSURVEY

AND CÓRREGO DO FEIJAO

TAILING DAM

On January 25, 2019, Dam I of the Córrego do Feijão mine in Brumadinho (Minas Gerais, Brazil) collapsed. The causes that led to this tragic accident are still being investigated by the Brazilian authorities and by the mining company that owns the exploitation.

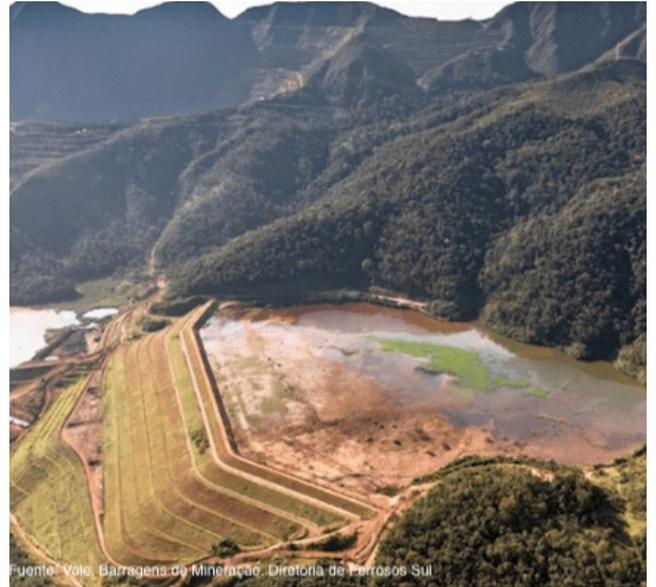
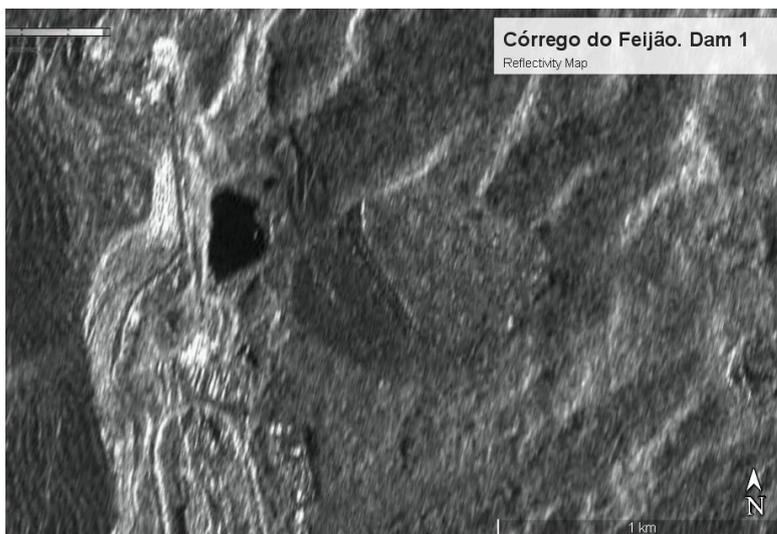
The characteristics of the MotionSurvey service offered by Land, Water, and Dams (LWD), and thanks to the radar images captured by ESA's Sentinel-1 satellite prior to the sinking of the raft, allow us to know the movements that were taking place in the body of the dam, months before it collapsed.

For this, a set of images has been taken that fully illuminates the geographical area where the Córrego do Feijão Dam I is located, and that covers the period from October 6, 2018, to January 22, 2019. Using tools specially designed for the interferometric treatment of time series of SAR (Synthetic Aperture Radar) images, the registered displacements during the mentioned period have been measured along the satellite line of sight (LOS).

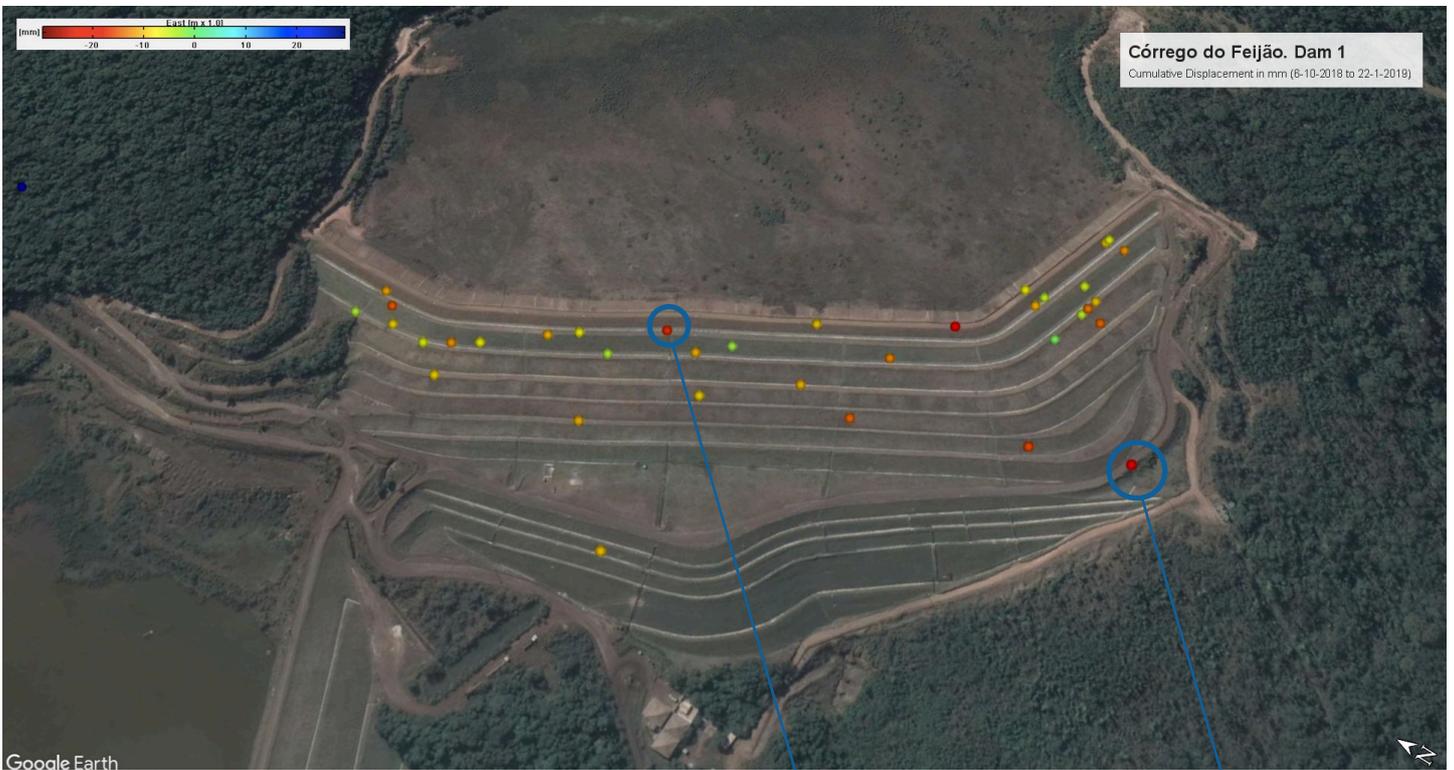
To ensure the reliability of the results presented, this work has been carried out by establishing a coherence criterion (value between 0 and 1) that requires that all the points used in the process have reached a value of 0.9 or higher.

As can be seen from the results obtained, in general, the downstream shoulder of the dam shows deformations with higher negative displacements than normal in almost all points. In addition, in two very specific areas (crest and the left bank of the dam), there are settlements with values that we consider especially relevant: displacements during the period in the vicinity of 20 mm and deformation speeds that are in the interval 70 and 80 mm / year.
